GOODERHAM & WORTS

HERITAGE PLAN REPORT #6

**INDUSTRIAL
HERITAGE
ASSESSMENT**

Prepared for Roger du Toit Architects

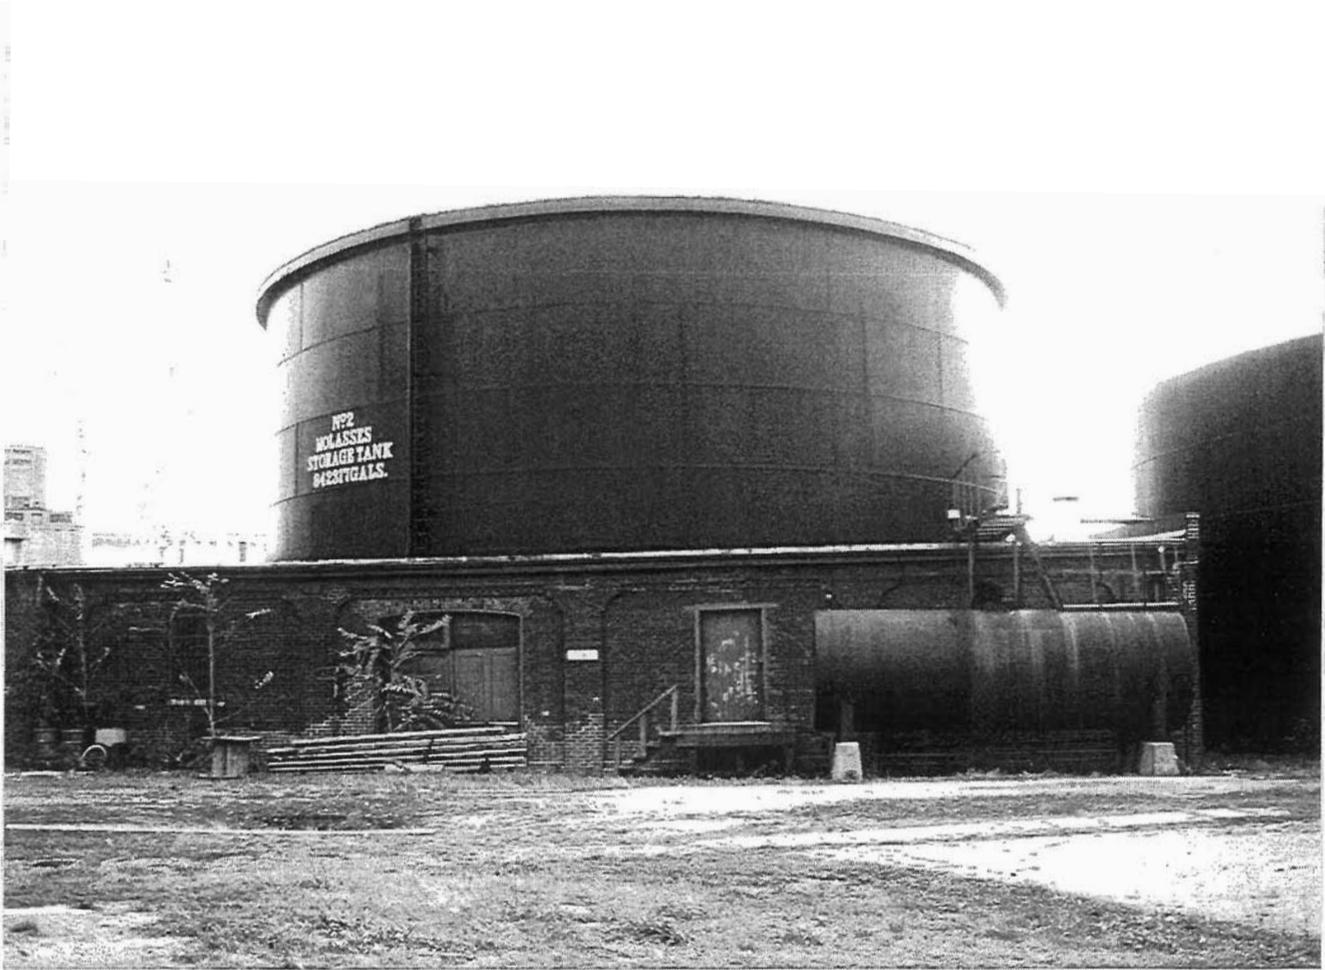
FIGURE B-17
Molasses Storage Tank No. 2 contained in building#9.
Source: *Historica Research Limited, November, 1993*

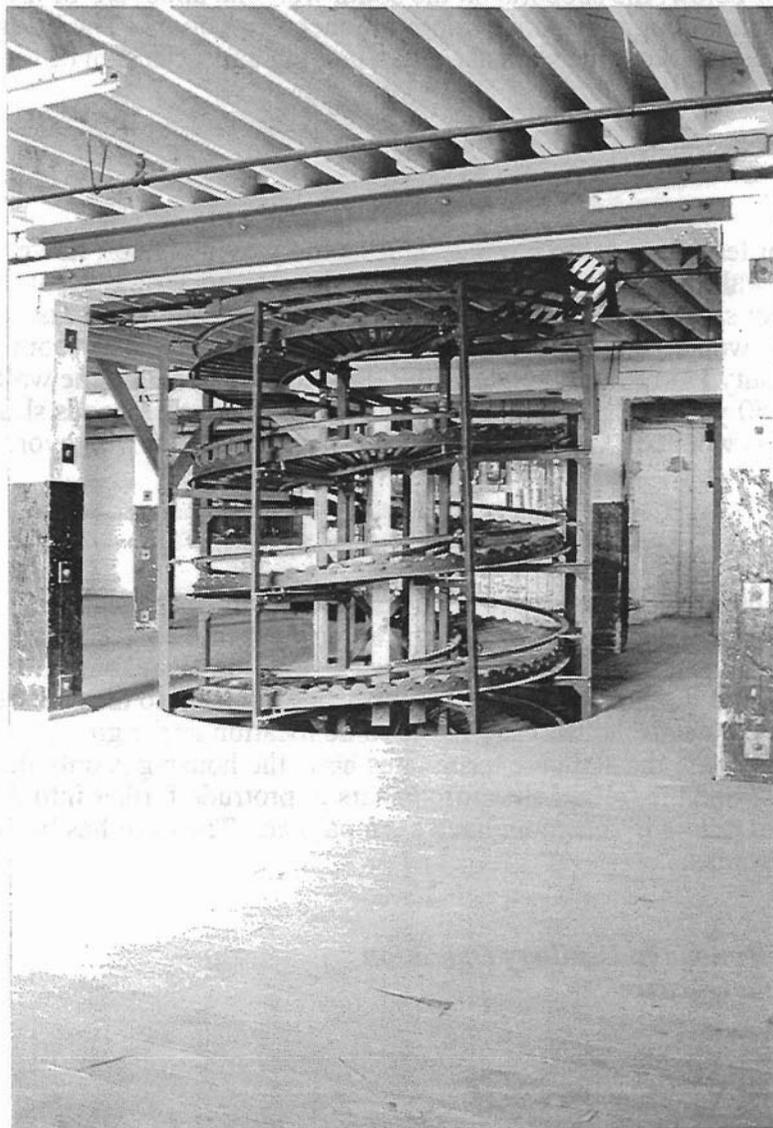
FIGURE B-36
Case goods slide on Floor 3 of Building #74.
Source: Historica Research Limited, January, 1993

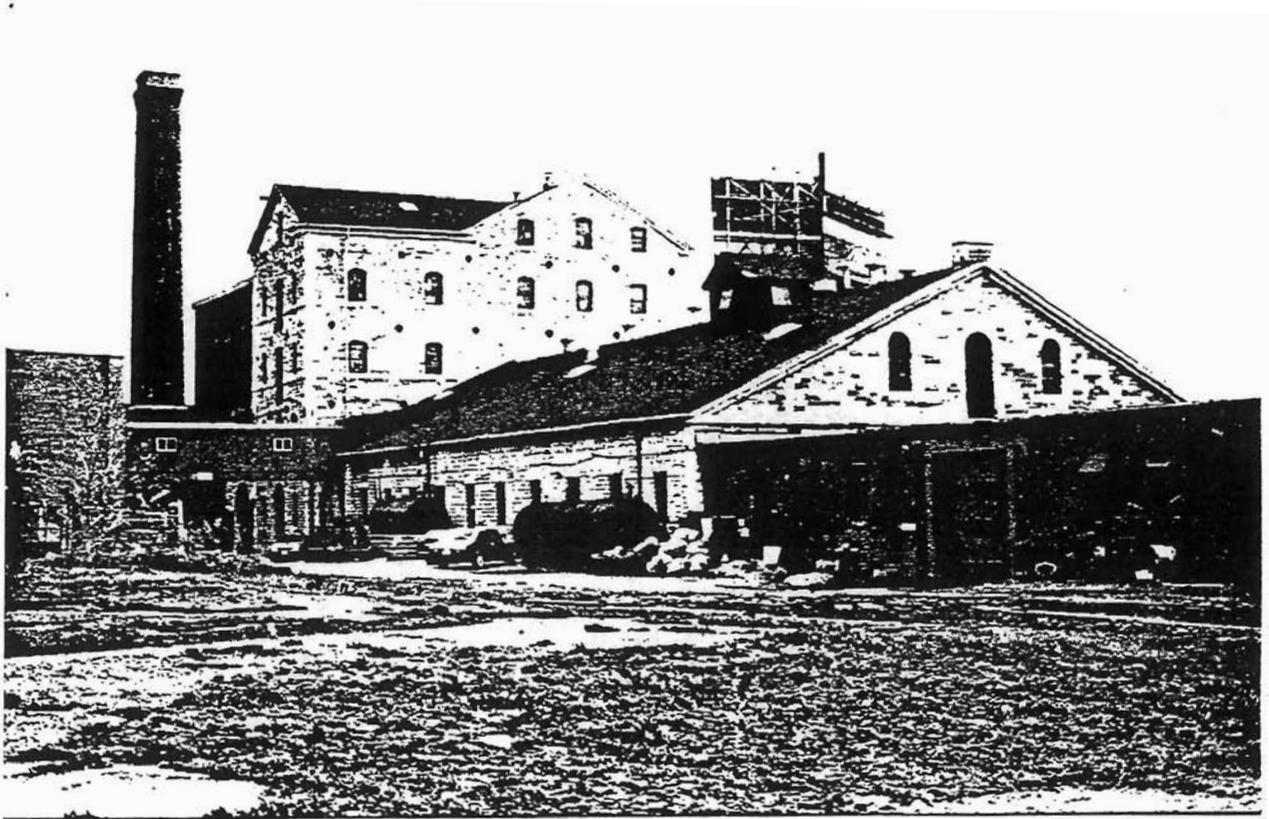
FIGURE B-38

Looking south east towards buildings #5-8. Note yeast culture penthouse on buildings #6-7, foot bridge connecting buildings #6, #25, and various tanks.
Source: Historica Research Limited, November, 1993

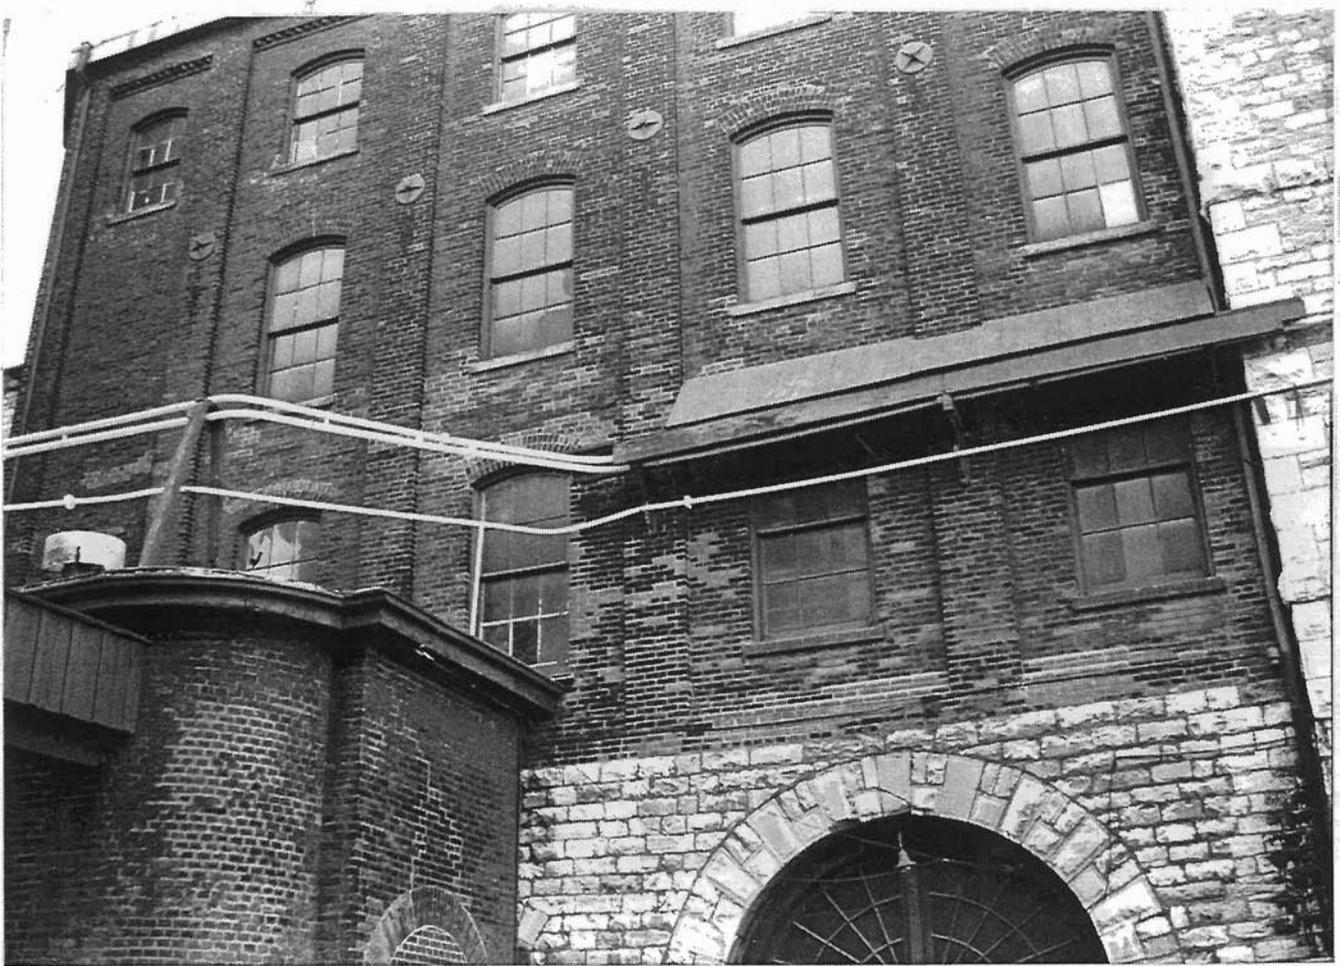
**FIGURE B-39**

The north wall of building #4 showing pipes attached to exterior of building.
Source: Historica Research Limited, November, 1993
