## Architecture: Vanished Neo-Classical Portico

**Earliest known views of the vanished portico to Building 31**

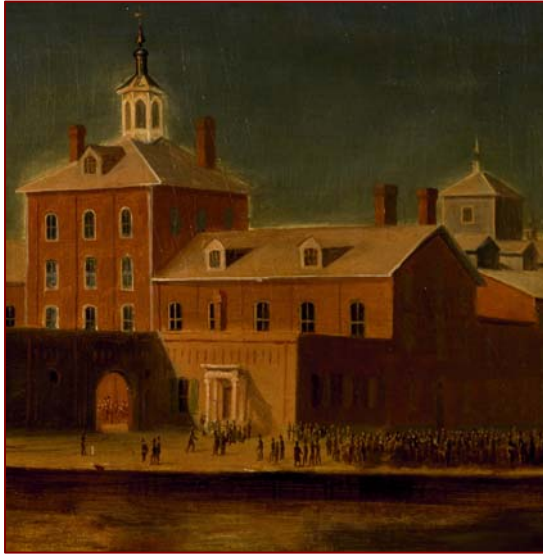
*Detail from October 1869 fire*

The primary evidence is contained in various artistic renditions of the building, notably 1869 and 1870 oil paintings and an 1877 chromolithograph found in an illustrated history of Toronto. Glimpses of a portico – or possible portico – are found in other documents, but these are the best views. And they appear to be good “eye witnesses” in favour of the earlier architectural element.

Both paintings were owned, and probably commissioned, by Gooderham & Worts. The 1877 view is a detail from a plate in Timperlake’s book at the City of Toronto Archives.

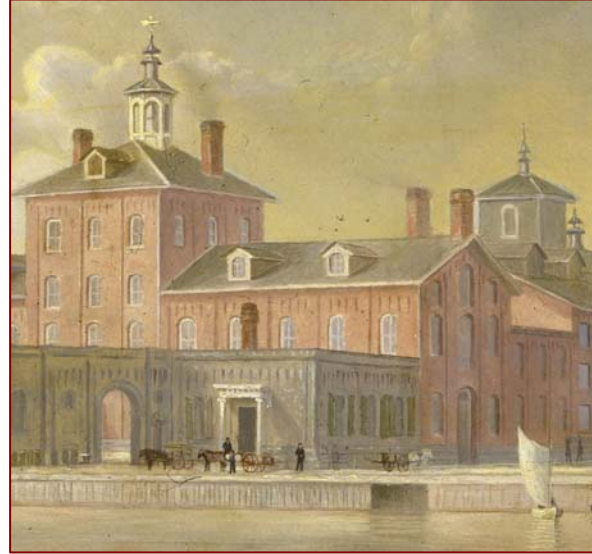
*Detail from May 1870 reconstruction*

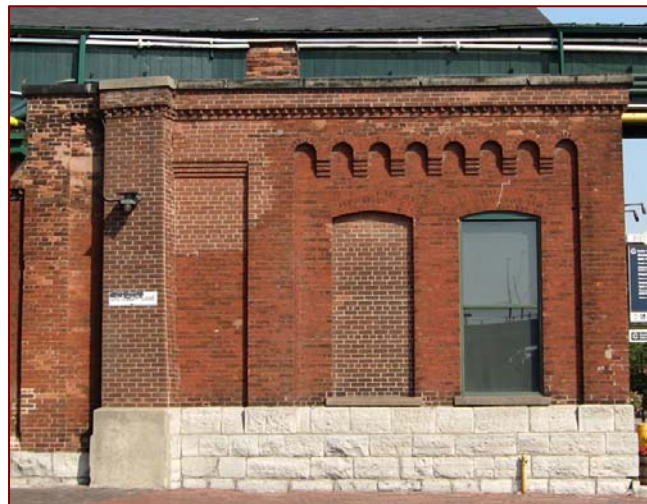
**South façade of Building 31 today**

Today, the south end of Building 31, overlooking Trinity plaza, shows evidence of extensive changes in its brick patchwork. It has a single remaining window, and decorative brick details, such as arcaded corbels and sawtooth pattern, found elsewhere on the site. But the current structure shows no evidence of a portico, let alone a beautiful, neo-Classical porch, with two steps, and elegant Ionic columns, framing a single door. So far, no building plans have been discovered and no photographs show a porch.
