## Heritage Chimneys

**Smoking chimneys, 1896: signs of “progress” at Gooderham & Worts and elsewhere in Toronto**

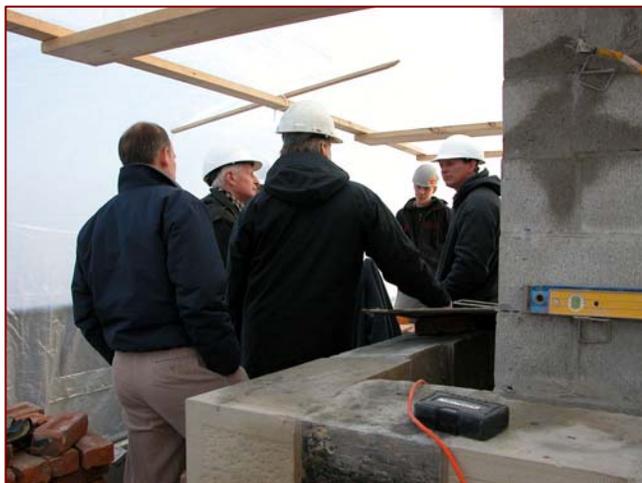
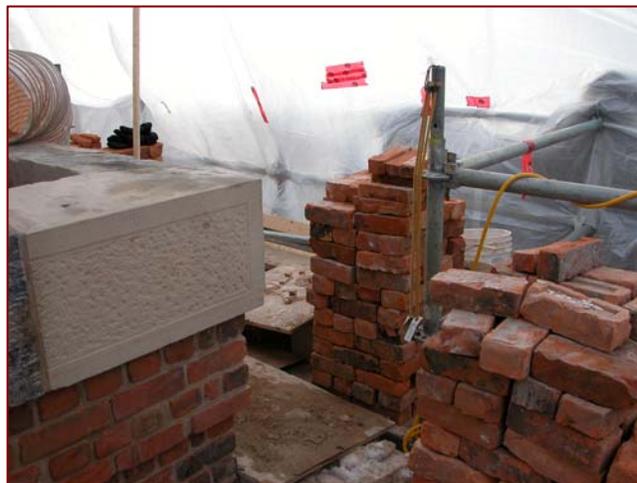
By 2006 the Stone Distillery chimney was in need of major repair. It would either have to be taken down permanently (as the Pump House Chimney had been in the 1930s) or rebuilt. As discussed in an [earlier article](#), a decision was made to take it down, rebuild it to a slightly lower height, and cap it with lead-coated copper to prevent future deterioration. With that (expensive) gesture, the Distillery District's, and Toronto's oldest remaining industrial chimney was saved from oblivion.

**High-level consultations atop the 1860 chimney, January 2007**

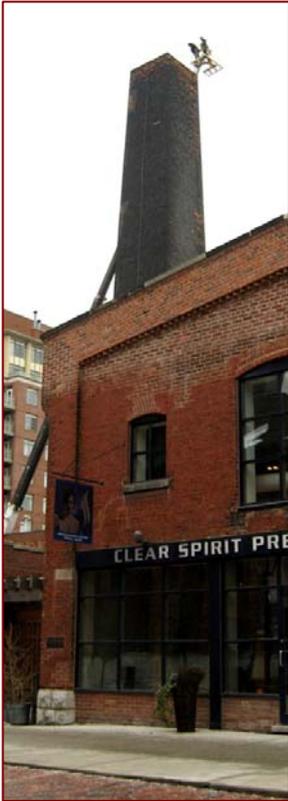
Repairing industrial chimneys is not for the feint of heart. The first task is to determine the extent of the damage, which can't be done simply by standing on the ground or pointing a telephoto lens. Close inspection of the top, the interior, and the full length is required. So in cold and dreary December 2007, a Distillery District mason and restoration architect donned safety gear, stepped into the bucket of a crane, and were hoisted 140 feet in the air. They poked at loose mortar, checked for cracks, and reported back that the damage wasn't as serious as feared. The chimney could be stabilized, rather than taken down and rebuilt.

Based on this inspection, as well as close study of the chimney base, a plan was devised, a scaffold raised, and repair work begun. Between St. Patrick's Day and Victoria Day, badly spalled and cracked brickwork will be replaced with about 2500 reclaimed bricks; the badly weathered, east and west sides of the chimney will be entirely repointed; the north and south sides will be repointed as necessary; and a lead-coated copper roof will be installed to prevent future damage

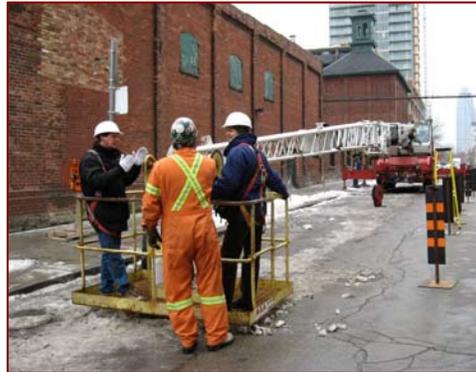
**Going up**

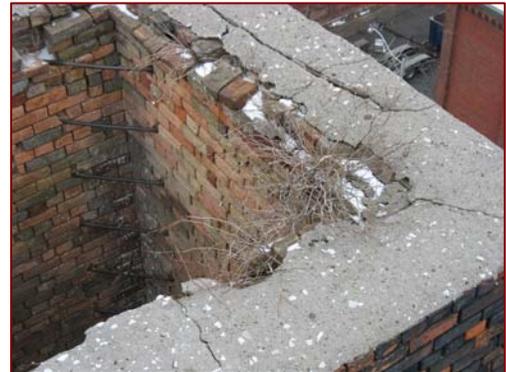
**Peering down**

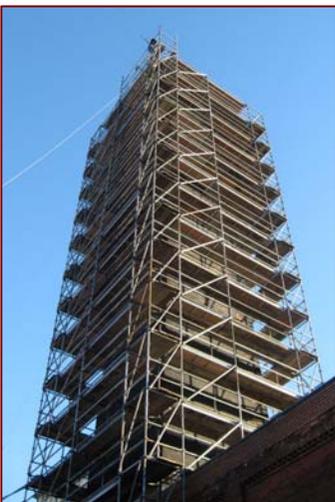
**Modern scaffold**
