Building Histories

Building 6: Fermenting Cellar

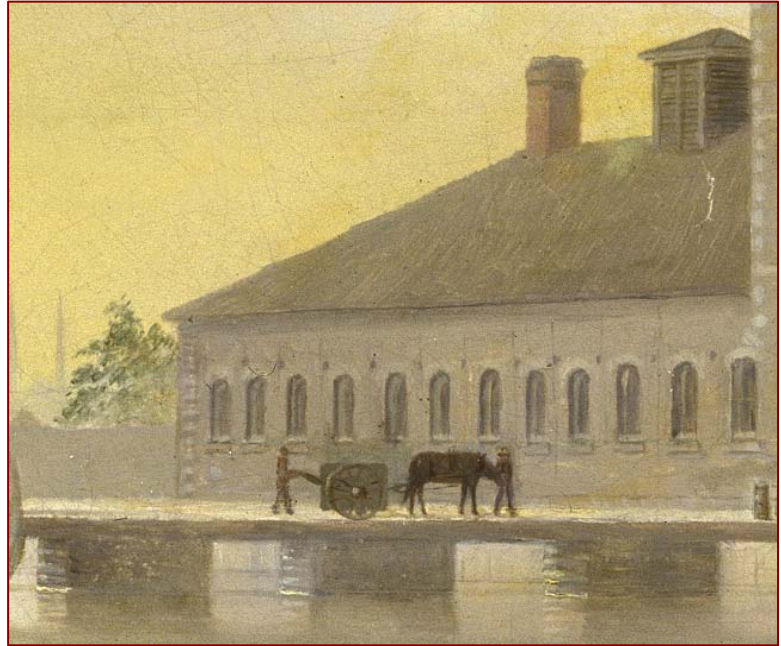
South side of reconstructed Fermenting Cellar, 1870
DHD

The exterior of today's fermenting cellar looks much as it did when it first opened in January 1861, and after it was reconstructed following the [great fire](#) of October 1869. Designed by David Roberts, Sr., the fermenting cellar was a one-and-a-half storey, limestone structure that stretched west from the five-storey stone distilling and milling building. Like the [adjacent distillery](#), it was parallel to the nearby shoreline, was composed of hammer-dressed coursed-rubble masonry and was punctuated by a dozen, regularly spaced windows with massive stone sills and lintels. Three of these windows were later replaced by doors. The 1863 view of the north façade indicates that there were windows in the roof for light and/or ventilation. Until the late 1960s, [the roof](#) was slate.

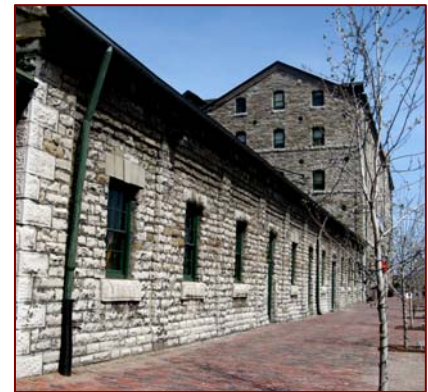
Fermenting Cellar today

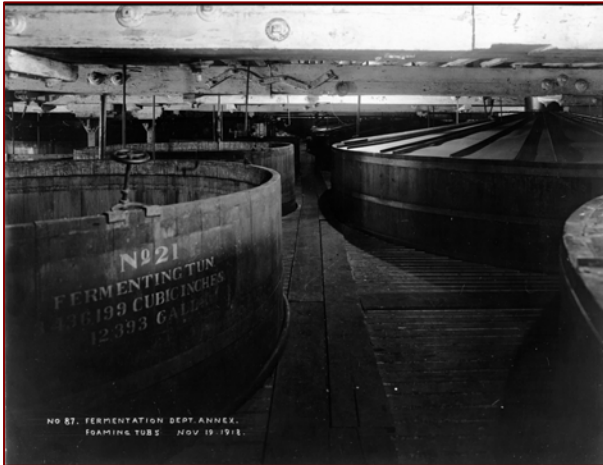
Tops of wooden fermenting tuns, 1918
CTA 1583-87

By 1882, for example, the fermenting cellar contained 46 wooden tuns, each 16-feet in diameter and 8.5-feet high. During the Great War, wooden tuns started to be replaced by copper ones. And at its twentieth-century peak, the floor was covered by copper tuns, about 16-feet tall, placed on raised concrete bases, and overlooked by catwalks, some of which remain. Throughout its working life, Building 6 emitted a rich – some would say overpowering – scent of fermentation, both inside and outside the building. The purpose of the building was evident to all the senses.

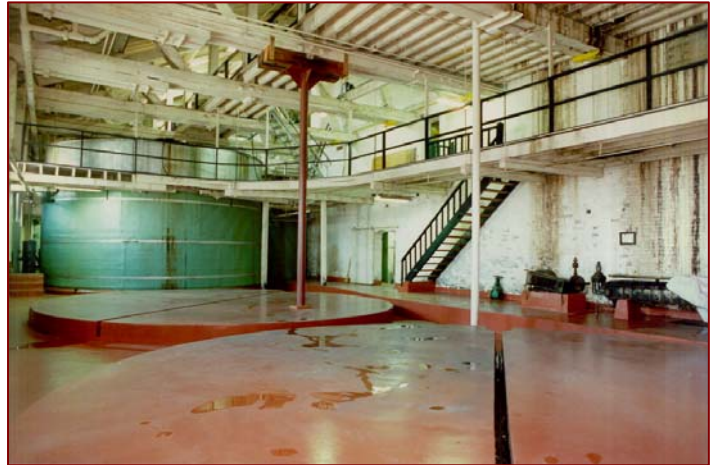
Copper tank and empty bases, ca. 1986
by Larry Turner, DHD

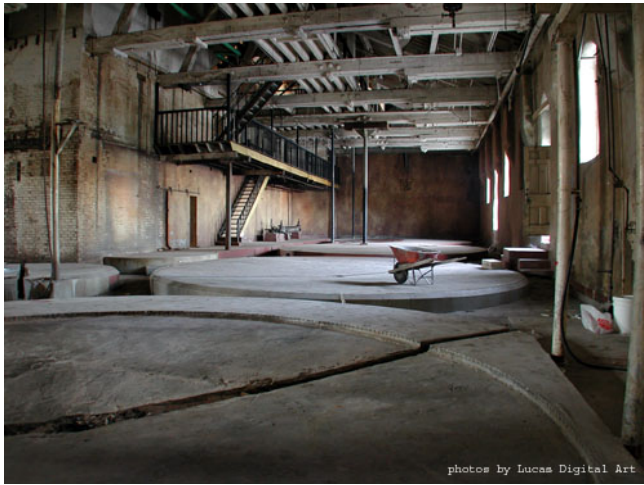
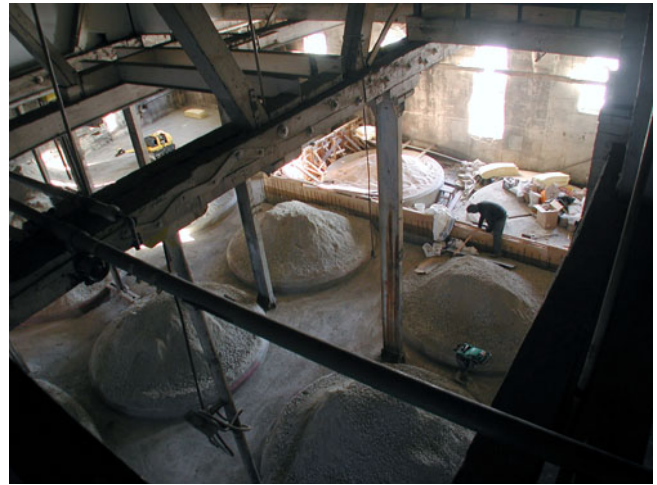
**Most of the fermentation tank bases disappear under a new concrete floor in 2003
by Thane Lucas**

When Cityscape took over the Distillery District in December 2001, the Fermenting Cellar was a great, “industrial” volume with a strange floorscape of giant concrete disks. What “new” use could replace and reinvigorate this part of the site? In 2003, the new owners decided to transform the old fermenting cellar into a modern event venue exuding “industrial chic.” Much of the industrial era remains on view. Rough walls. Double timber beams resting on limestone corbels and steel columns. Open rafters and remnants of catwalks. But a level floor was required for safety and functionality, so most of the tank bases were buried under a smooth layer of concrete. To reveal and celebrate the industrial heritage of the building, however, parts of four circular tank bases were left uncovered near the main door. Note the size, the depth, and the slits where pipes were attached to the tanks.

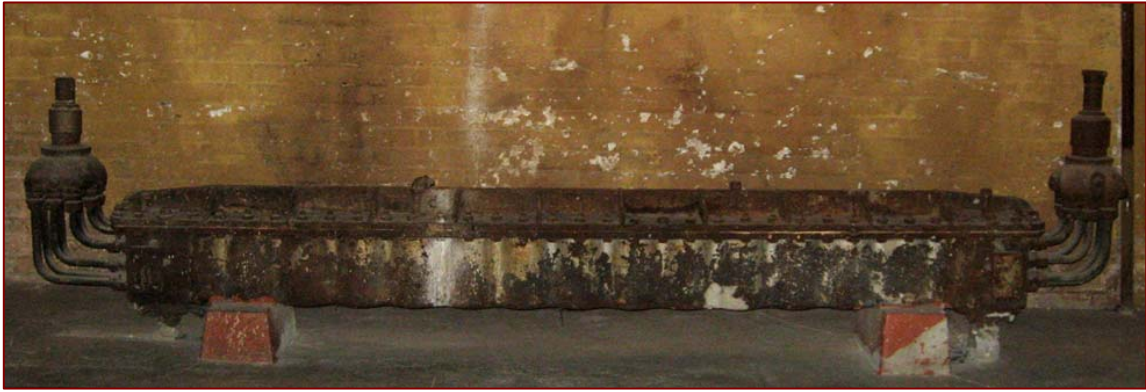
Water filter unit (6-1-3), ca. 1900

Although none of the big copper fermenting tuns has survived, other important industrial artifacts are on display. To mark the important relationship between fermenting and mashing, one of the mammoth (16 x 10 x 7 foot), early-twentieth-century “[mash cookers](#)” (5A-1-3/4) that used to be on the ground floor of adjacent Building 5 was cut up and the two ends mounted on the south wall. Above it, the 20-foot [auger feeder](#) (5A-2-5) that directed grain into the cooker is mounted. Under the stairs stands a small [mash cooker](#) (5A-2-6) dating from about 1910. And just to the west is a long, low, cast-iron [water filter unit](#) (6-1-3) dating from about 1900 that can be seen in some of the other illustrations.
