Building Histories

Buildings 58 & 59: storing, bottling, canning

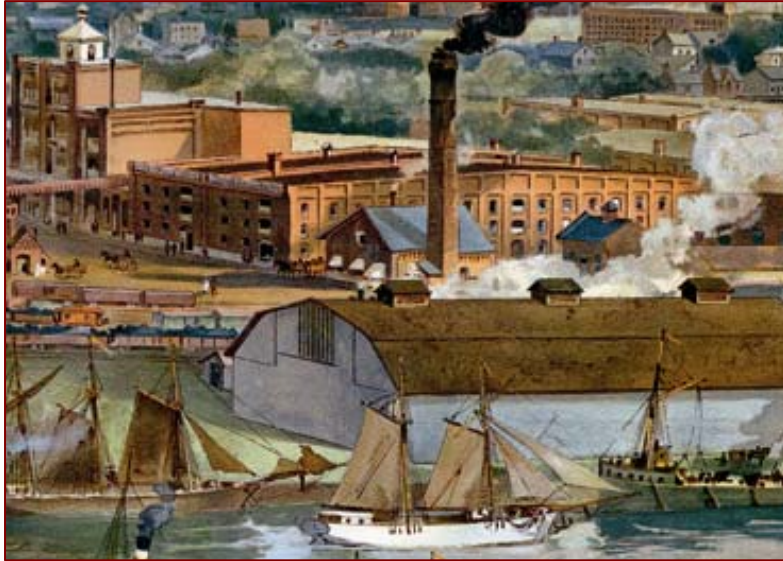
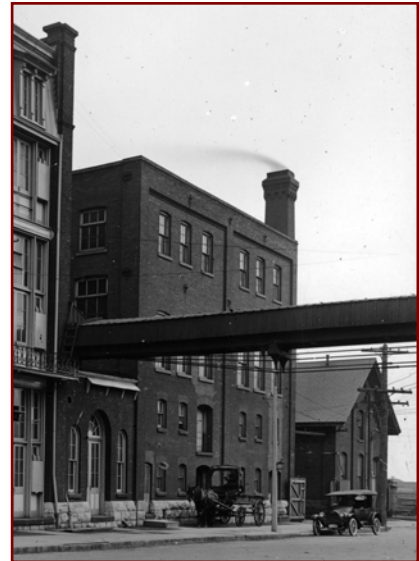
Between [1896 \(left\)](#) and [1918 \(right\)](#) the 3rd floor was rebuilt and a partial 4th floor added

Unfortunately, no details of the earliest efforts have been found. Given later history, however, it seems highly likely that bottling operations were centred in Buildings 58 and 59 and that these buildings were reconfigured in the early part of the twentieth century when the third floor was rebuilt, larger windows were installed, the pitched roof was replaced with a flat roof, and a partial fourth floor was added to provide space for three large scale tanks.

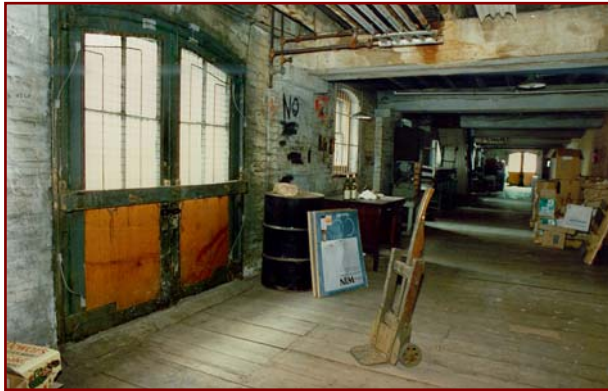
Building 59 1st floor looking toward Trinity St.

Turners' photographs also reveal the original interior construction and final configuration of the Cannery buildings. They show, for example, that the first two floors of Buildings 58 and 59 were long, narrow, open spaces, separated from one another by brick fire walls. Red-and-silver-painted iron columns held up the double timber beams resting on projecting brick-and-stone corbels that

supported the very low first and second floor ceiling ceilings. The long south facade of Building 59 contained rows of segmental-headed, two-over-two-pane, wood-framed windows, while the north walls of both buildings were blank.

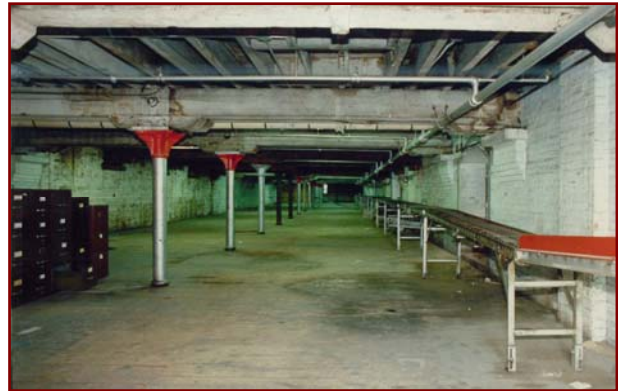
Building 58 2nd floor storage & old conveyor

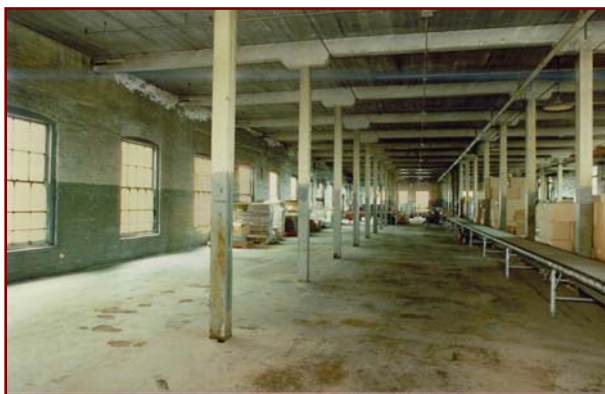
Building 58 & 59 3rd canning floor

By contrast, the third floor of the Cannery was twice as wide (embracing both buildings), about twice as high (14-feet), with square wooden posts supporting the single timber ceiling beams. It was also far better lit, with large, square-headed, eight-over-eight-pane, wood-framed windows on all four sides. The 20-foot-wide fourth floor contained a Fairbanks scale tank and two large mixing tanks on raised platforms. Brick walls on all floors were painted silver.

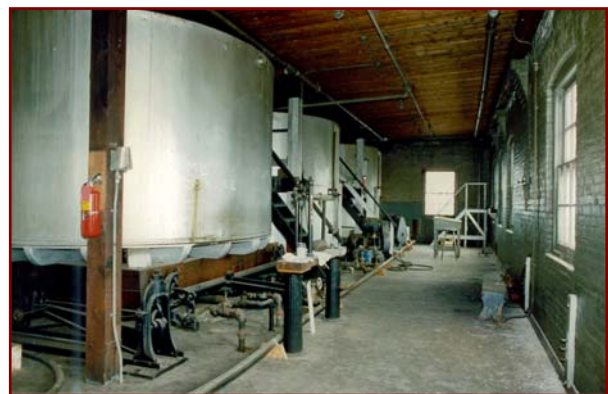
Building 58 & 59 4th floor tank loft

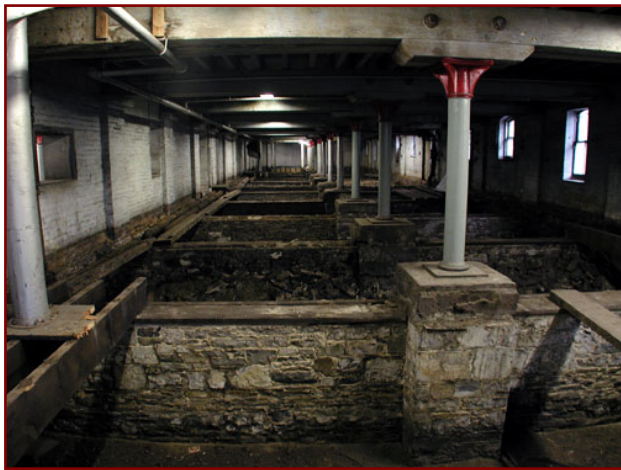
Cannery wood floor removed Thane Lucas

Perhaps the most dramatic change was lowering the entire ground floor about two-and-a-half feet. The original wood floor sat on a series of parallel limestone-rubble foundation walls. The floor was removed, each foundation wall was carefully lowered, rubble was removed, and a new concrete floor was constructed on the lowered foundations. The iron columns holding up the second floor beams were left standing on their original stone foundations. The results can be seen and admired today. Be sure to note the islands of stone under the columns that show clearly how far the floor was lowered.

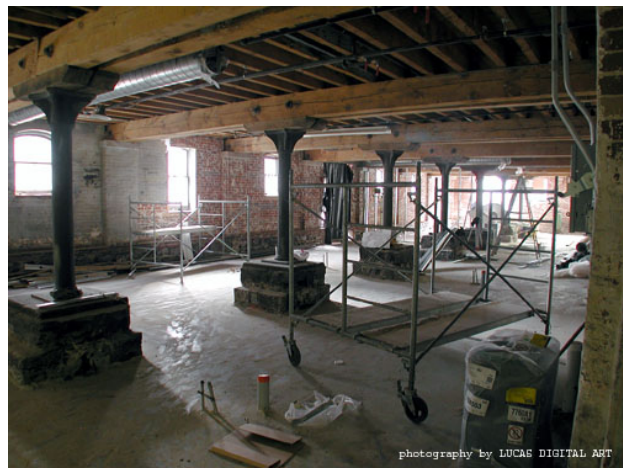
New floor & sand-blasted walls Thane Lucas

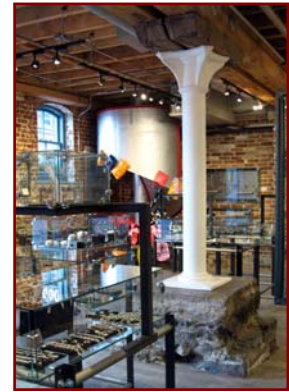
Column, Building 59
